Environmental Control System (ECS) Malfunction Procedures Symptom 1 to 37 - SSR1 + Notes - Feb. 12, 1968 Group

National Aeronautics and Space Administration (NASA)

SM2A-03-SC101-(2)
APOLLO OPERATIONS HANDBOOK

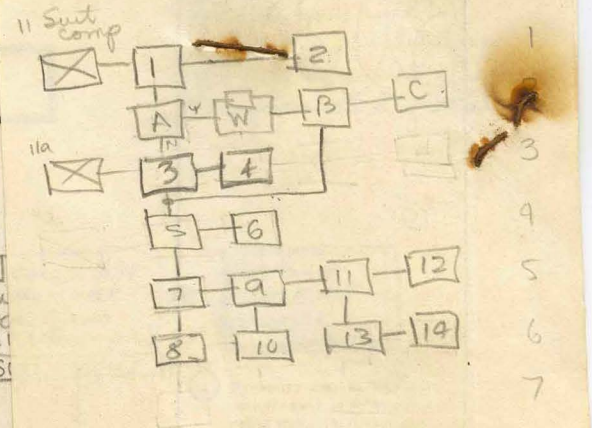
⑥ Subsequent compressor operations verified by monitoring supply hose and humidity levels

③ With this vent open CO₂ PP will remain < 7.6 mm Hg.
② Humidity and CO₂ control lost

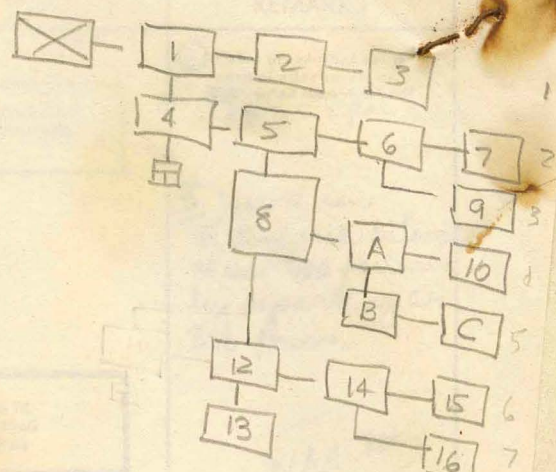
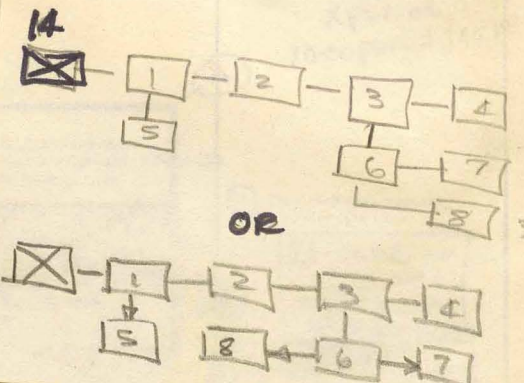
subsequent
A if O₂ mask use
necessary, turn
PLSS vlv - full.
Excessive O₂
consumption results

- ① Maintain fully suited mode. Excessive O₂ consumption if cabin pressure is maintained.
- ② Maintain close position on leaking valve. Cabin pressure relief valve redundancy lost.

NAA quest
① What is O₂ leak rate thru
wiredump nozzle
② Do there on airfare in
the wiredump dump?
NO - the airfare is
at the tip where there is
a .055 orifice

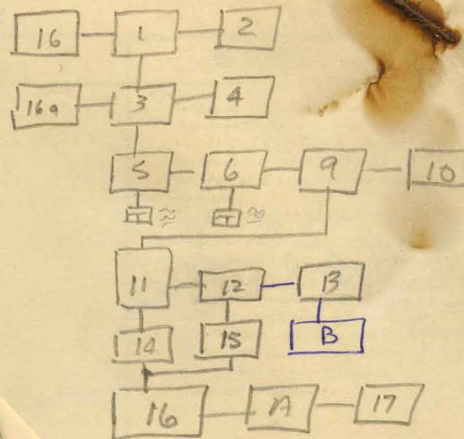
low flow, of boiling
glycol in line. Monitor Gly. Evap
outlet temp for >35°F

3A MSFN can aid in
determining gly evap
operation by comparing
gly evap temp in and out.
Evap out
boiling 40-43°F
not boiling 43-48°F
initiated when rad
out 48-50.5°F

will a prop valve
or isol valve failure
cause low gly temp
same for stagnated panel

4 MSFN can aid in deter-
mining frozen/stagnated
panel by telemetered
primary radiator bay
temperature out
measurements and
primary glycol flow rate.

5 If GLY DISCH PRIM PRESS
indicator <40 psi proceed to
ECS malfunction procedure
20 PRIM GLY DISCH
PRESS LOW

6 Absence of water boiling
and normal primary
radiator inlet tempera-
ture only indication of
primary radiator outlet
temperature.

7 The thawing process may
be expedited by acti-
vating the secondary
coolant loop. Panel 1 is
located between +Y and
+Z axes. Panel 2 is
located between -Y and
-Z axes.

8 Blockage of radiator flow
cannot be distinguished
from a stagnated panel.
Single panel is less
effective, therefore
electrical loads should be
reduced.

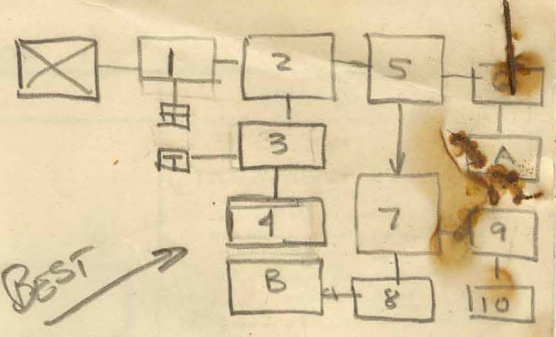
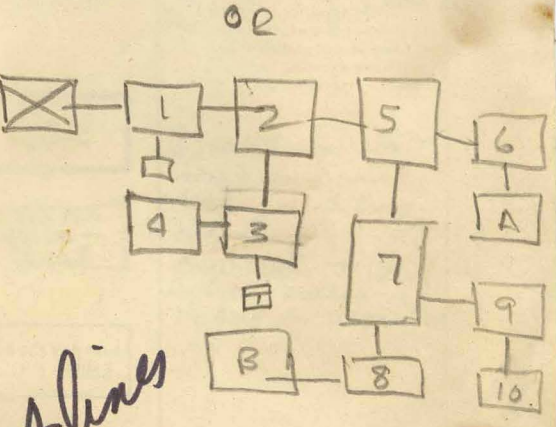
and continued trouble shooting

- 1 Repetition of this step may be necessary.
- 2 Reduction of electrical loads may reduce evaporator inlet temperature so that water boiling is not required.

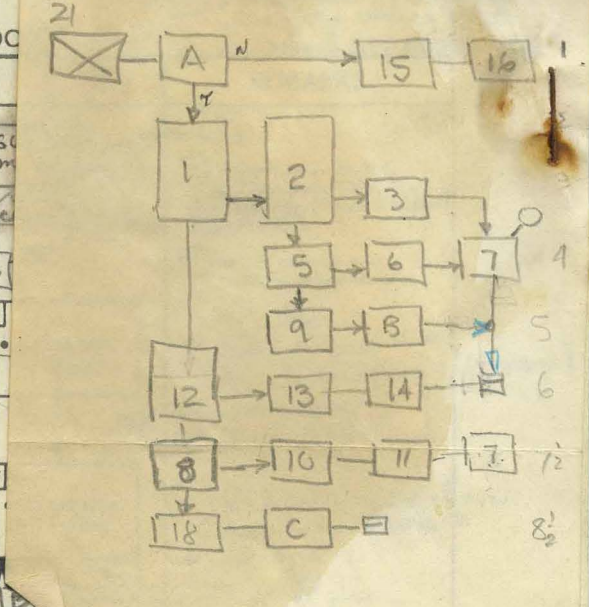
3 All indications of glycol quantity are lost.

4 With pump off glycol discharge pressure should equal 1/4 accumulator quantity.

5 Use primary coolant in evaporator mode when required for G & N operation. Constraints are evaporator H₂O consumption.

6 If the glycol leak is slow (2.5%/hr) the leak source may be more rapidly detected by momentarily placing the gly accum vlv off after each component is isolated.

SYMPTOM	PROCEDURE	REMARKS
<p>20 PRIM GLY DISCH PRESS LOW</p> <p><40 psi</p> <p><40 OR</p> <p>< ACC QTY 4 +32 psi</p>	<p>1 ACCUM PRIM QTY ind low (<30%)?</p> <p>YES</p> <p>ECS 21 1</p> <p>PRIM GLY ACCUM QTY LOW OR DECREASING</p> <p>2 Switch operating ECS gly pump to redundant bus Gly disch press incr?</p> <p>NO</p> <p>3 REDUCED PUMP OUTPUT DUE TO ELEC PROBLEM</p> <p>4 ECS GLY PUMPS - OFF (momentarily)</p> <p>Gly disch press decr?</p> <p>NO</p> <p>5 GLY DISCH PRESS IND FAILURE</p> <p>6 Return to original gly pump</p> <p>ECS RAD HTS - ORIG CONFIG</p> <p>7 Switch to redundant gly pump</p> <p>Gly disch press incr?</p> <p>NO</p> <p>8 DEGRADED GLY PUMP DEGRADED OR FAILED</p> <p>9 Verify sensor</p> <ul style="list-style-type: none"> ECS GLY PUMPS - OFF PRIM GLY ACCUM vlv - OFF (CW) PRIM ACCUM FILL vlv - ON <p>Gly disch press 18-22 psi?</p> <p>NO</p> <p>10 GLY DISCH PRESS SENSOR FAILURE</p> <p>11 Return to original gly pump</p> <p>12 PRIM ACCUM FILL vlv - OFF</p> <p>PRIM GLY ACCUM vlv - ON (CW)</p> <p>Gly disch press compatible for indicated accum qty?</p> <p>YES</p> <p>13 DEGRADED OUTPUT OF BOTH GLY PUMPS</p> <p>NO</p> <p>14 ACCUM PRIM QTY IND FAILURE</p> <p>15 Return to original gly pump</p>	<p>LOW VOLTAGE (AC?)</p> <p>LOW FREQ</p> <p>2 PHASES OF PUMP POWER</p> <p>(A) With Radiators bypassed, pumped press is nominally 2 psi lower than with radiators operating</p> <p>1 Degraded glycol pump may be verified by checking GLY PRIM COLDPLATE flow rate with MSFN</p> <p>2 With ECS GLY PUMPS - OFF, glycol discharge pressure should equal 1/4 accumulator quantity indication.</p>

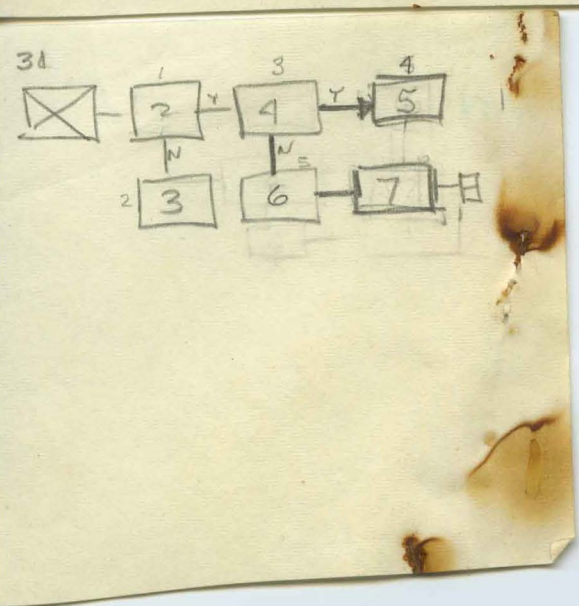
SYMPTOM	PROCEDURE	REMARKS
<p>35 VACUUM CLEANER SUCTION LOW</p> <p>35a FECAL CANISTER VACUUM LOW</p>	<p>1 Change vacuum cleaner debris bag</p> <p>Suction normal ?</p> <p>YES 2 DEBRIS BAG CLOGGED OR EXPENDED</p> <p>NO</p> <p>3 Replace WMS filters</p> <p>Suction normal ?</p> <p>YES 4 CLOGGED FILTER</p> <p>NO</p> <p>ECS 34 3</p> <p>URINE OVBD DUMP NOT DRAINING</p> <p><i>note change</i></p>	<p>1 Assumes second WMS hose is disengaged.</p>
<p>36 INADEQUATE VENTILATION AFTER LANDING</p>	<p>1 Cycle PL vent sw</p> <p>Ventilation incr ?</p> <p>NO 2 Actuate PLVC</p> <p>PLVC - OPEN</p> <p>Ventilation incr ?</p> <p>YES 3 ATTITUDE SENSING SW FAILED CLOSED</p> <p>NO 5 PLV FAN FAILURE</p> <p>4 Resets attitude sensor relay to resume PLV operation</p>	<p>2 Ventilation available not opening either hatch</p> <p>1 Postlanding vent switch must be cycled to off and back to high (low) anytime SC attitude exceeds 60° to reset the attitude control relay.</p>

<p>37 WATER INFLOW AFTER LANDING</p>	<p>1 PLVC - NORMAL</p> <p>Water inflow stops ?</p> <p>NO 2 PL VENT - OFF</p> <p>CAB PRESS RELF vlv (2) - CLOSE</p> <p>Water inflow stops ?</p> <p>NO 3 UNCONTROLLABLE WATER INFLOW INTO SC</p> <p>YES 5 ATTITUDE SENSING SWITCH FAILED OPEN</p> <p>4 Inflow caused by open PLV vlv</p>
